Big Creek Watershed Improvement Plan

Prepared for
Forsyth County Engineering Department

Prepared by
CH2MHILL

October 2007

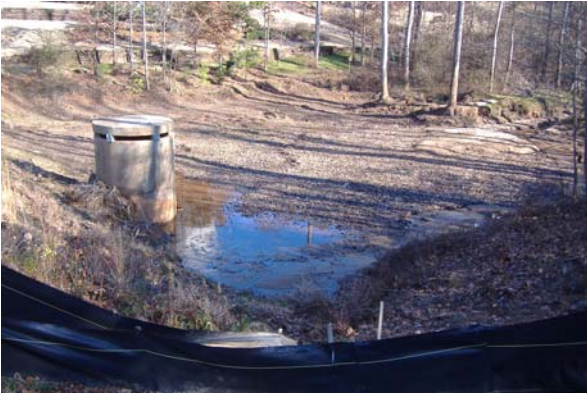
Photo 1

The field reconnaissance identified BMPs that were functioning properly, as well as BMPs with potential problems in functioning and design. Of the 39 initial potential BMP retrofit projects, 21 projects were identified as requiring retrofits and selected for evaluation in the cost and benefit analysis in Section 4.0. Just over half of the 21 projects were located in BC05 and CN01, which are the two priority subwatersheds with the highest impervious cover. In many instances, BMP structures were providing inadequate stormwater capacity and were (1) designed for use during construction and then abandoned after serving their build-out purpose (Photo 1), (2) in-stream features actively contributing to degraded channel conditions (Photo 2), or (3) improperly built or maintained to serve a useful purpose (Photo 3). Recommendations for these projects are summarized in Table 3. Recommended project techniques are discussed in the following section. Project locations are shown in Figure 6.

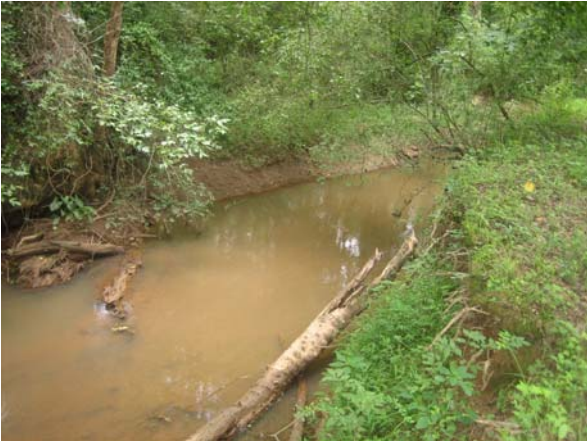
Photo 4

The field reconnaissance identified some stream reaches that appeared to be stable, but most showed signs of degradation. Of the 10 initial potential stream restoration projects, 8 projects were identified for potential restoration and selected for evaluation in the cost and benefit analysis in Section 4.0. Seven of these projects were identified in priority subwatersheds. Sedimentation and erosion were problems found at many reaches (Photos 4, 5, 6). In addition, reaches often had inadequate vegetative buffers (Photo 7). All of these problems decrease channel stability and available habitat to support robust aquatic communities. Recommendations for these projects are summarized in Table 4. Recommended project techniques are discussed in the following section. Project locations are shown in Figure 7.
